How the old Sunshine Skyway Bridge may have collapsed on 9 May 1980

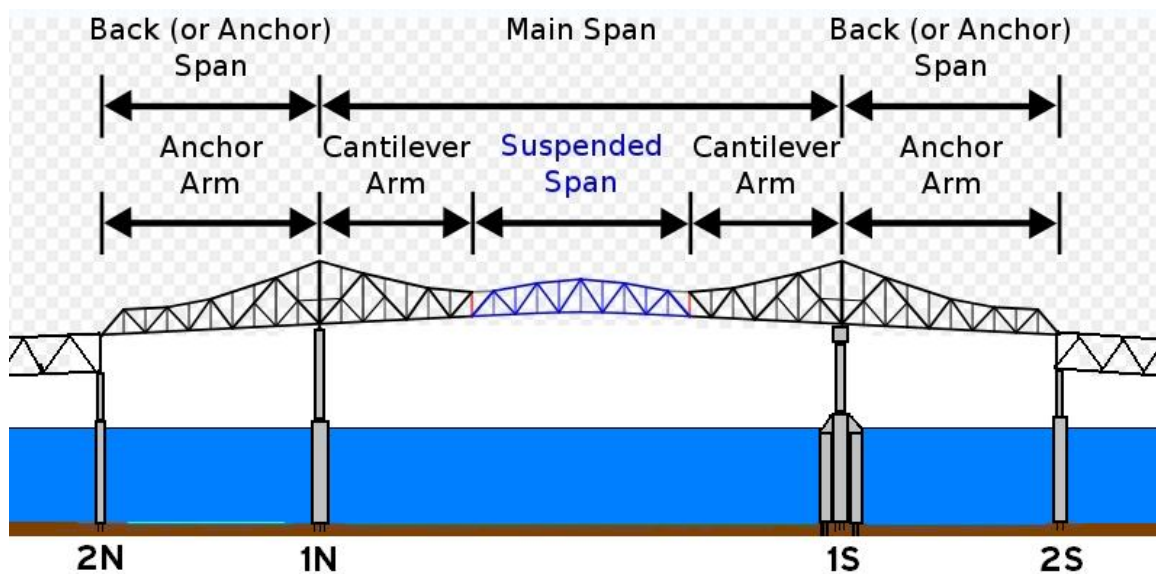
Diagram of the old Sunshine Skyway southbound span

You know basically how a cantilever bridge works. It is a center span supported by two arms on each end that sit on a pier and are anchored on each far end. So far upon impact the Sunshine Skyway's southbound span lost the southern anchor pier (Pier 2-S) and the bridge that went with it up to the expansion joint just north of Pier 1-S in the main channel.

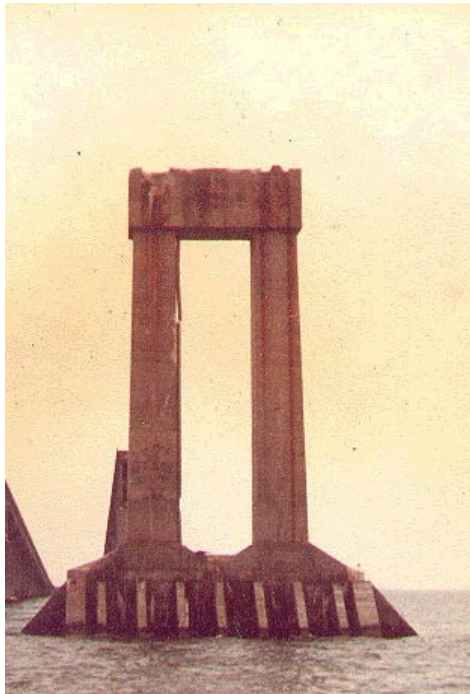
Construction on the southbound span began in 1967 for a 1969 opening but the span did not open to traffic until 1971 due to major settling within Pier 1-S, the major support pier directly south of the channel. Piles were re-driven utilizing steel pilings similar to the 1954 northbound span into limestone to correct this major flaw but the pier ended up having a different look than the major channel pier to the north, Pier 1-N, which was constructed identical to the two main channel piers of the 1954 northbound span.

A photo of Pier 1-S taken in 1981

Now why did Pier 1-S – the Skyway southbound span's main channel pier that looks different than the other Skyway main channel piers due to repairs completed in 1969 – stood yet did not provide support to the failing southbound span on impact? Pier 1-S, as well as its companion 864 feet to the north of the Tampa Bay shipping channel, Pier 1-N – *do* support the superstructure 150 feet above the water but in essence these main piers act as a center of balance for the southern and northern cantilevers. In other words, the cantilever mounted on the main channel pier in the center is akin to a see-saw, only the ends are held up by the center span and the back span.

The forward impact of the Summit Venture upon collision with Pier 2-S pushed the failing span forward creating the tilt and fall effect. As Pier 1-S had no way of supporting the southern cantilever on its own weight, the entire southern cantilever probably split into two – thanks to a sturdier northbound span Pier 1-S which took a hit from the falling structural steel – as the span tilted and fell into Tampa Bay.

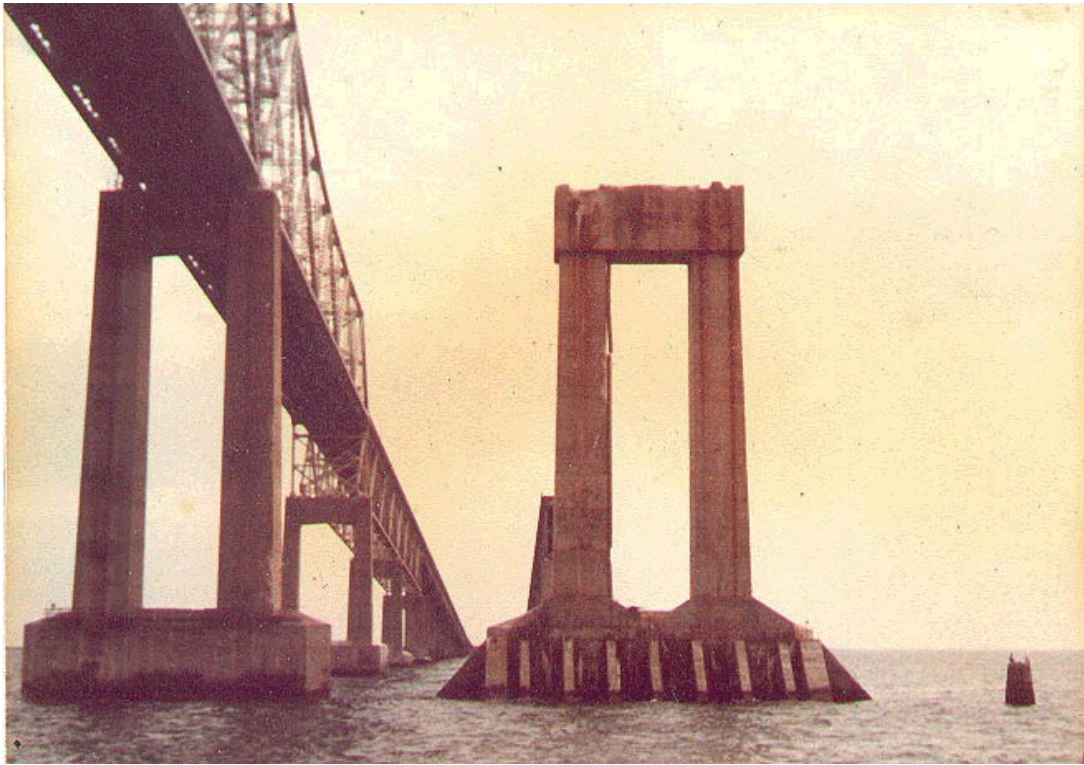
Another photo of Pier 1-S showing its counterpart holding up the northbound span, also taken in 1981. The space between the two piers is where the southbound span fell into after impact by the Summit Venture. The two piers are different as the pier to the right was the one repaired in 1969 due to settling and cracks which required pilings driven deeper below the water surface until limestone was reached.

Upon collapse, the damaged southbound span came to rest for the most part on the bottom of Tampa Bay. However, a good majority of the damaged southbound span came to rest upon the space between the Pier 1-Ses on both the northbound and southbound spans. But thanks to the design of the Pier 1-S on the northbound span, it basically came through unscathed save for a gouge mark on the edge.
